Site 14 Town Creek

Overview: The Town Creek salt marsh is located approximately 4 mi upstream from the mouth of the Merrimack River. There are approximately 350 ac of tidal wetlands upstream of the abandoned railroad embankment owned by MBTA. These wetlands are affected by a severe tidal restriction and predominately consist of large monotypic stands of *Phragmites*. Past studies of the tidal restriction have found the tidal range was reduced by approximately 3.5 ft upstream of the railroad embankment and an additional 1.5 ft upstream of Route 1A. Former salt marsh upstream (or east) of Route 1A is currently dominated by *Phragmites*, *Typha* or other palustrine wetlands. There is a number of low lying commercial properties along Route 1A which abut the marsh. Flow is conveyed via a 4 ft by 4 ft stone box culvert through the railroad embankment and a 36 in pipe under Route 1A. Several smaller culverts under Route 1A do not appear to provide any tidal exchange. There is a wooden flapper gate installed on the downstream end of the stone box culvert. When the railroad line was built in the mid-1800's, there was reportedly an 80-foot long trestle at Town Creek (J. Ray, MBTA pers. comm

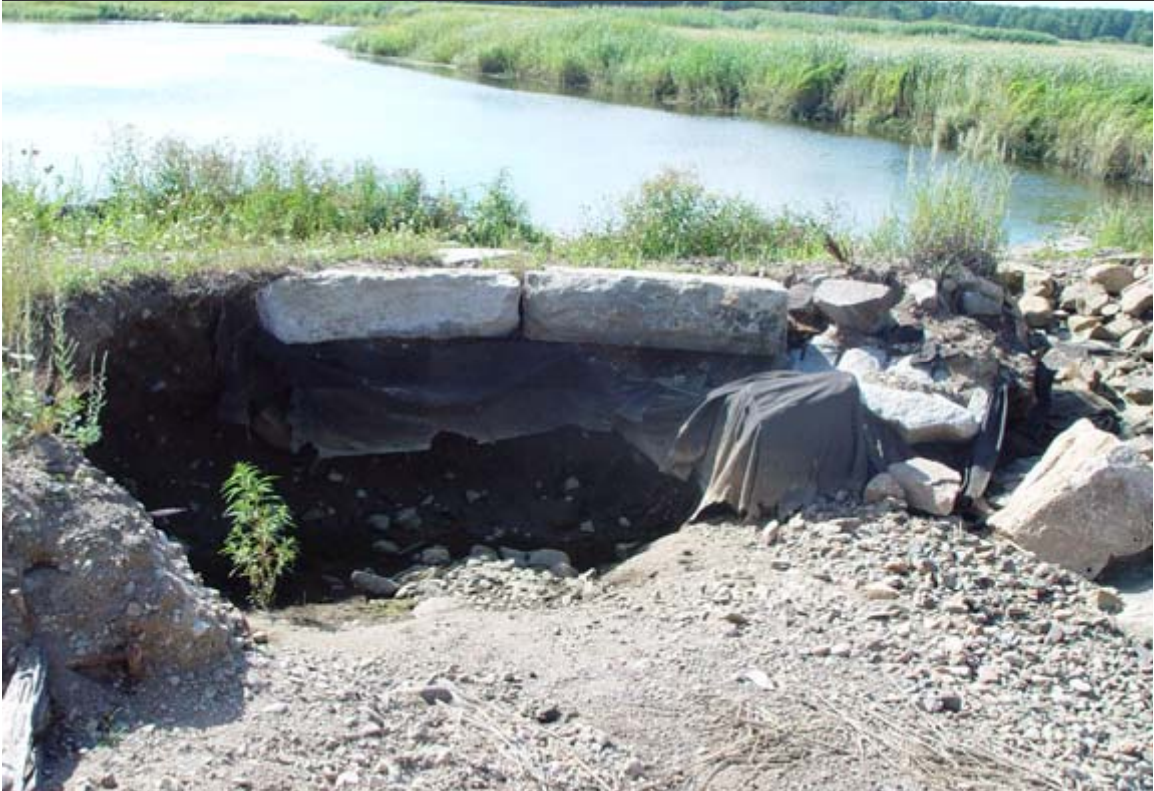
Photo 1 - Downstream View of Crossing

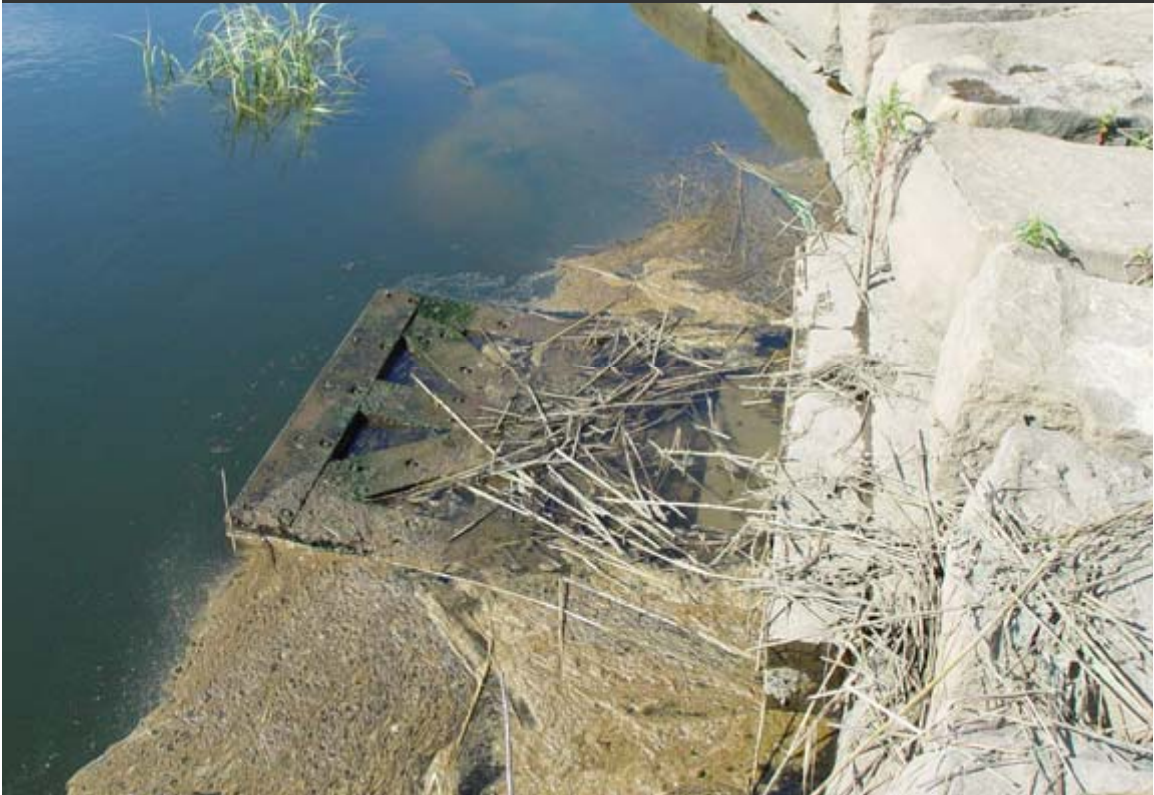
Structure conditions: Town Creek passes through the railroad embankment via a 4 ft by 4 ft stone culvert. The culvert is approximately 85 ft in length. The downstream toe of the embankment is armored with a low retaining wall of large cut stone. The downstream end of the culvert is fitted with a heavy wooded flapper gate which is approximately 5 ft square. The gate has been subject to damage and vandalism and has been replaced or repaired several times (D. Levesque, DPW Director, pers. comm.). At the time of inspection, the gate appeared too buoyant and remained in an open position allowing the incoming tide to pass freely through the box culvert. Even in a closed position, the gate appeared to be poorly fitted to the culvert opening allowing significant flows to pass through. More recently, a manhole cover was attached to the gate allowing it to function more effectively as a flapper gate.

Photo 2 - Wooden Tide Gate

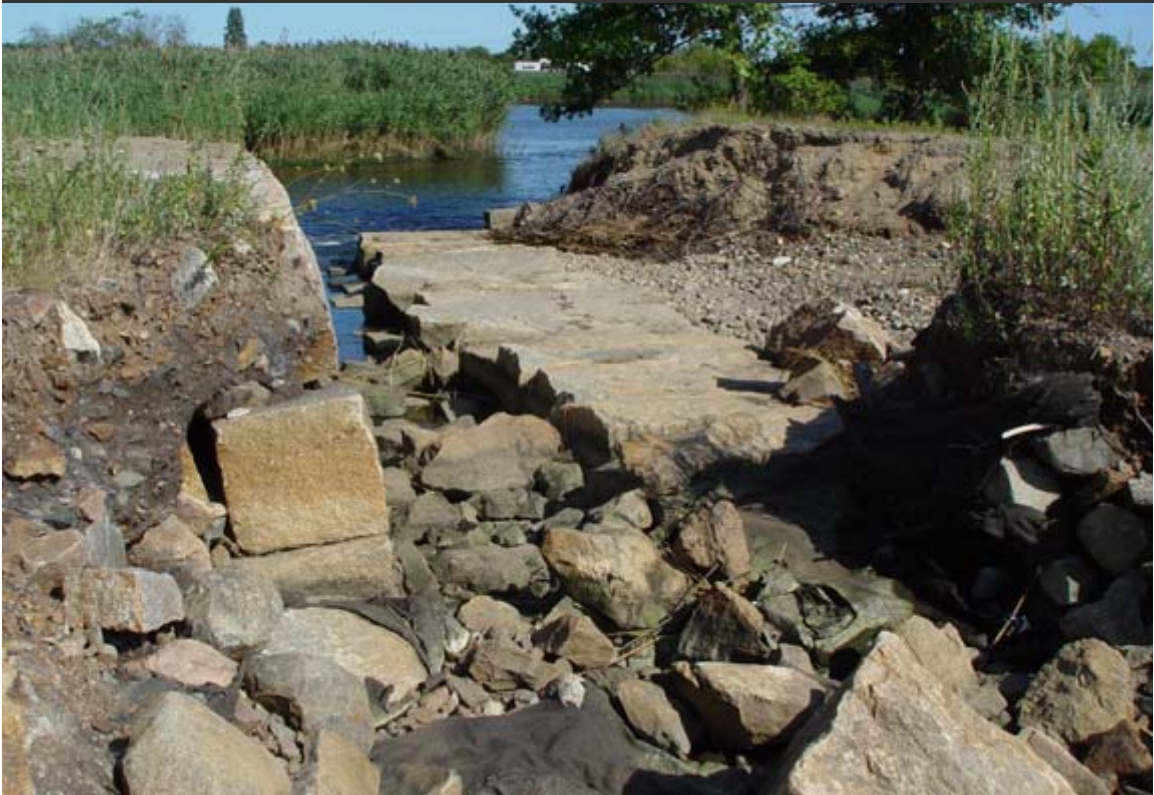
Photo 3 - Upstream View of Crossing

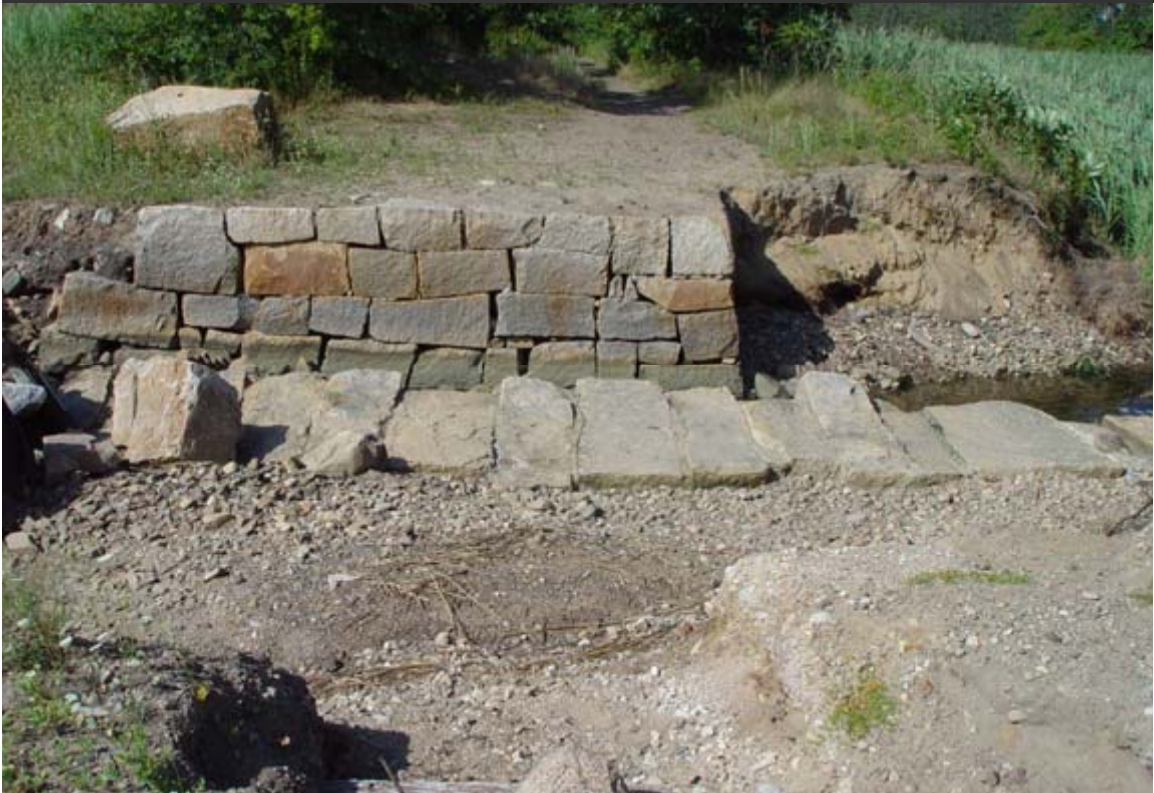
Photo 4 - View of Crossing to North

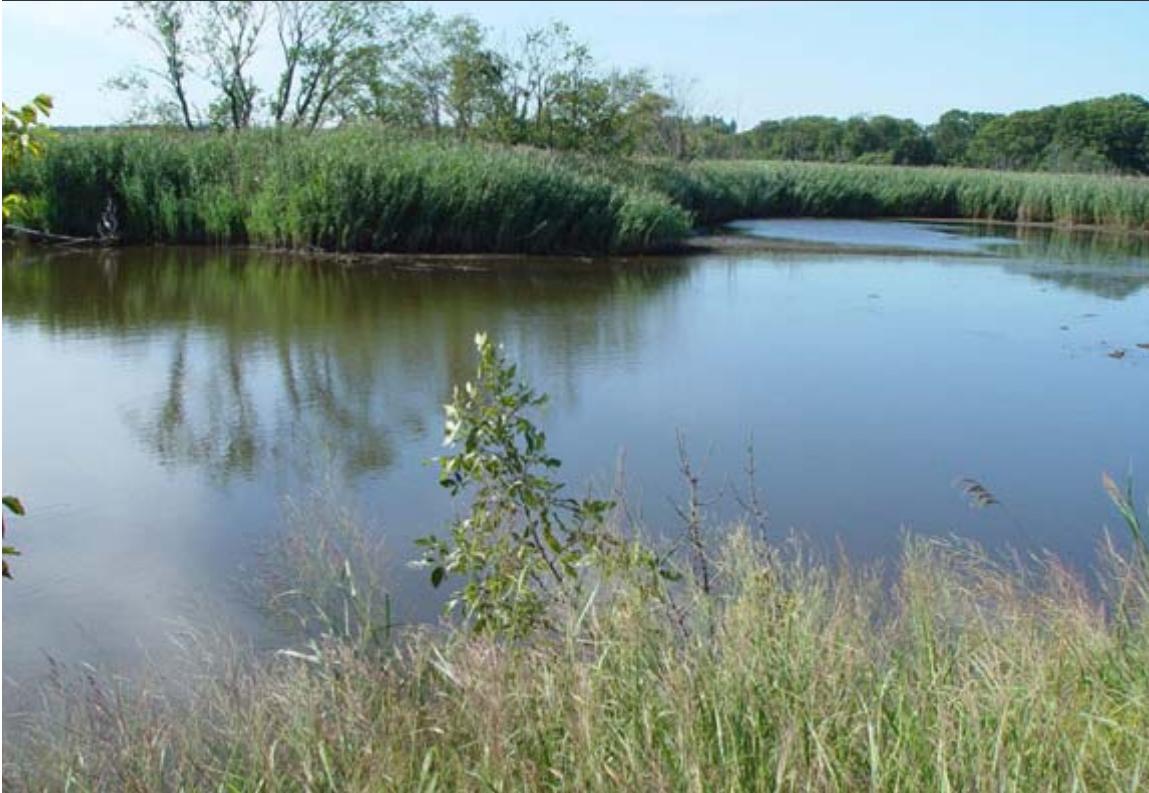
Photo 5 - View from Route 1 to Northwest

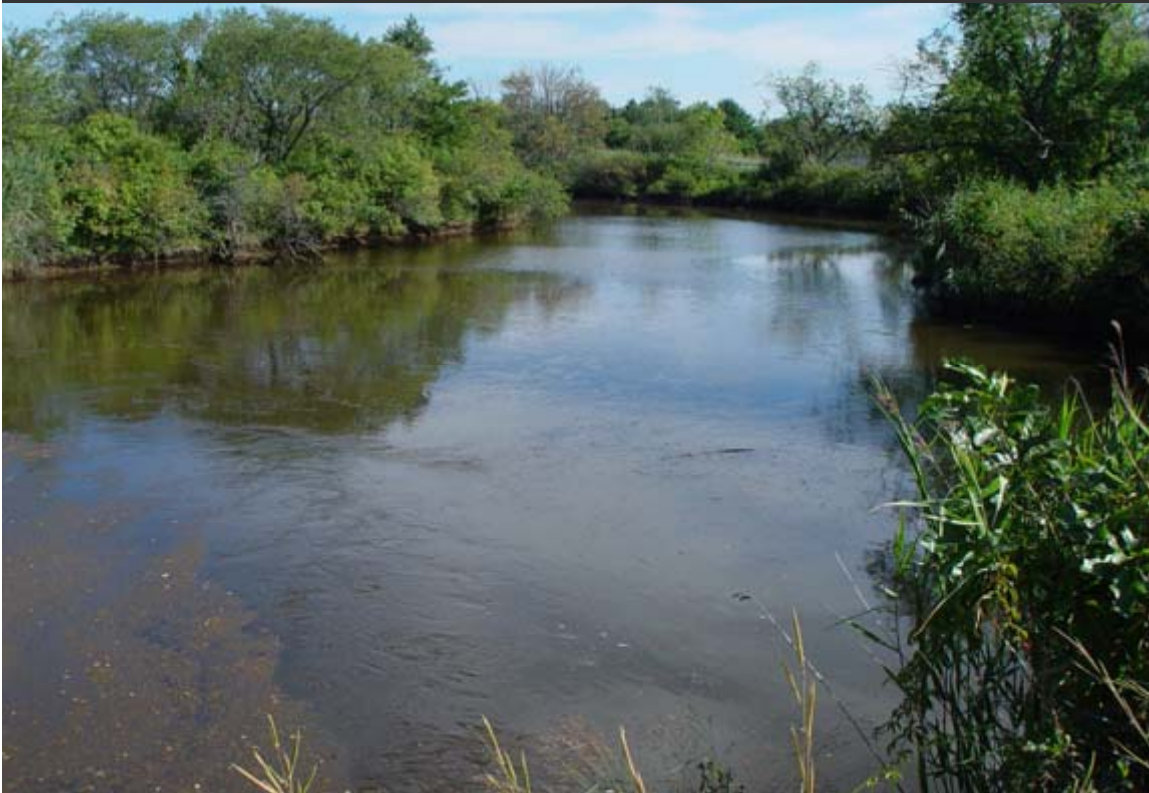
Photo 6 - View from Route 1 to Southeast
